**Precision 20/20
Full Reserve Study
for
Waterway
Pines
Holland, Michigan
March 6, 2012**

Client: Waterway Pines

Location: Holland, Michigan

Inspection Date: March 6, 2012.

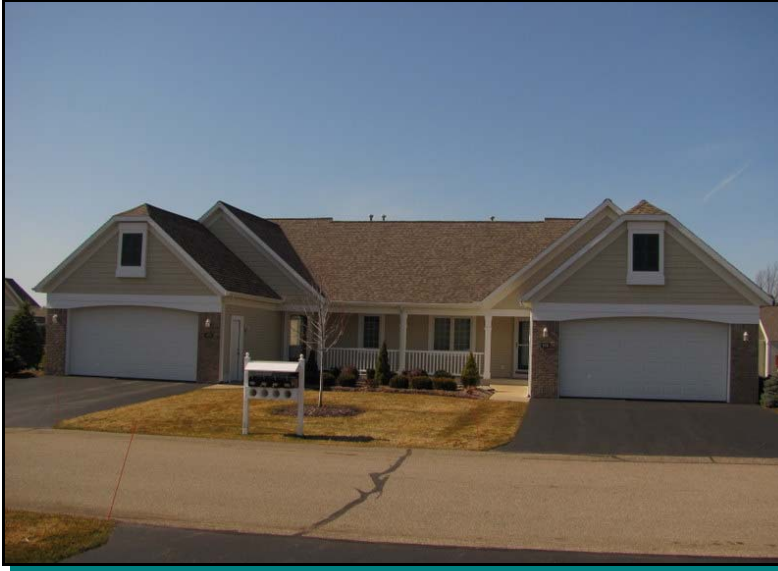
Front elevation, duplex units

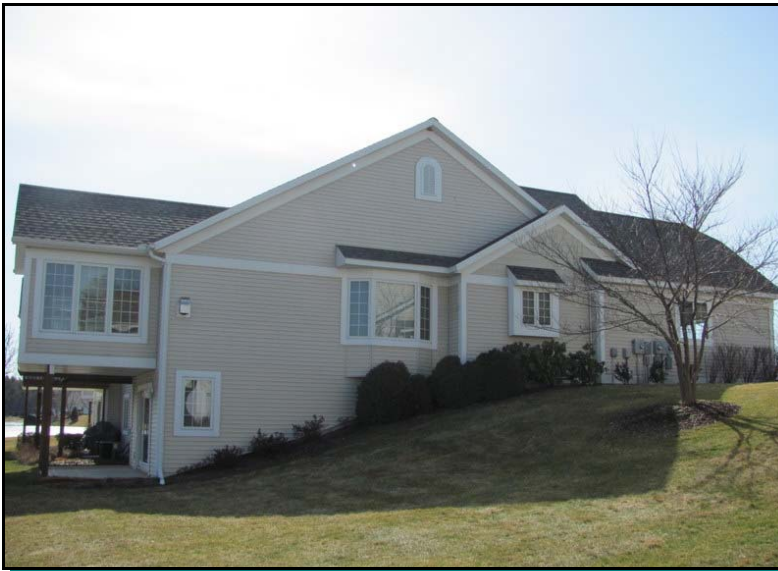
Side elevation, typical

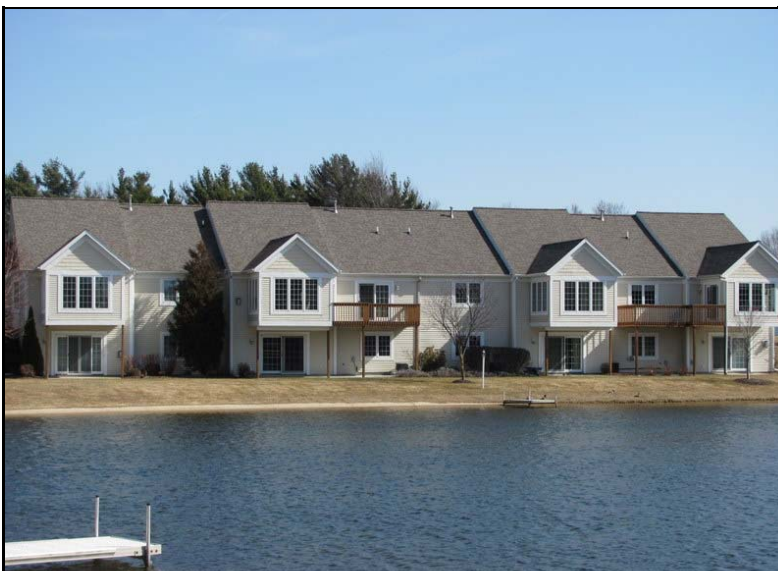
Rear elevation, fourplex units

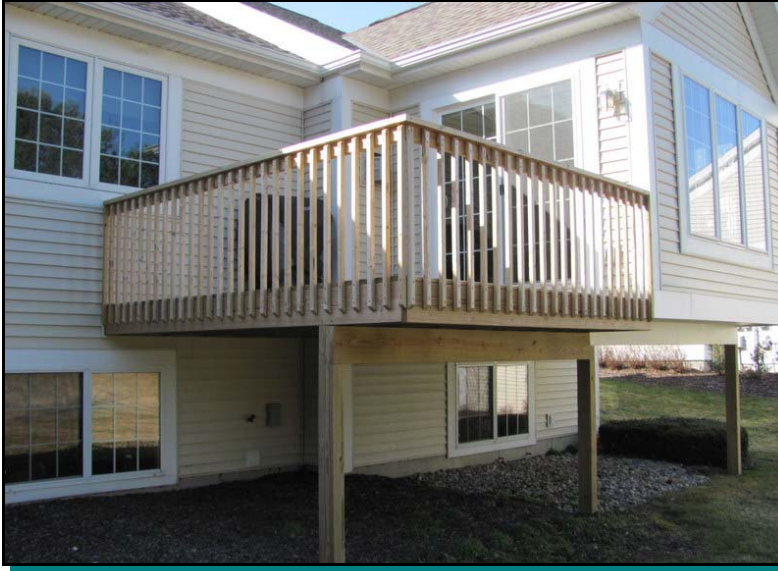
Balconies, Wood - The Association is responsible for the replacement of the 139 wood balconies which comprise a total of 14,480 square feet. The balconies are in good to fair overall condition at ages of 7- to 15-years. The Board informs us that the Association has replaced a limited quantity of deteriorated wood components. Wood balcony materials treated with a protective finish have useful lives of 20- to 25-years with proper maintenance. Proper maintenance should include the following activities funded through the operating budget:

Wood balcony

for economic or aesthetic reasons. We recommend the Association anticipate a phased replacement of the balconies beginning by 2022 and concluding by 2029. We depict this information on Line Item 1.120 of *Reserve Expenditures*.

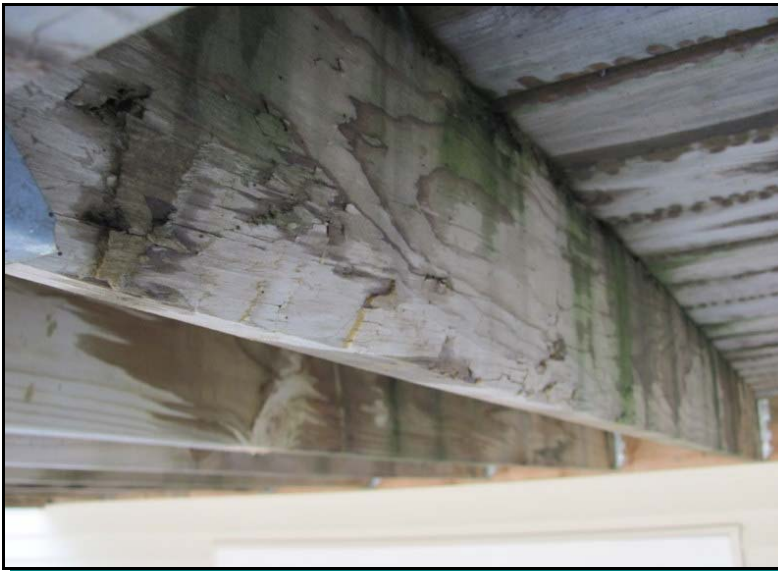
Minor deterioration at balcony joist

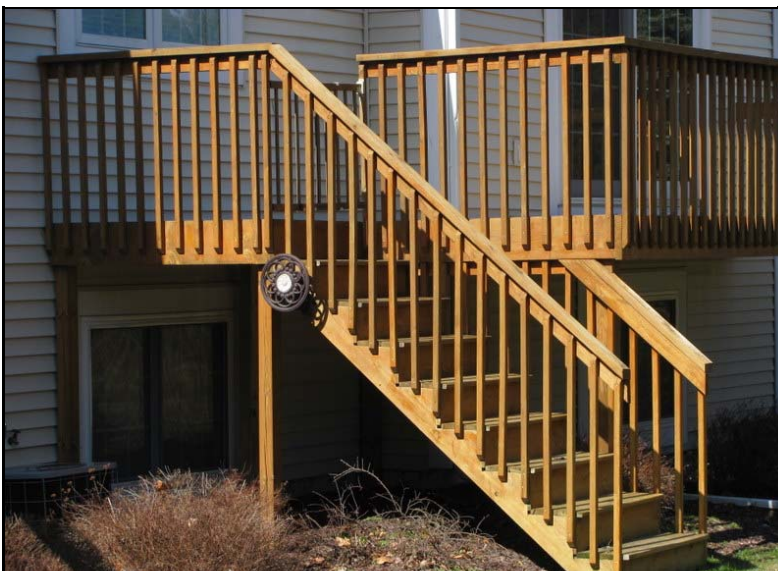
Wood balcony staircase

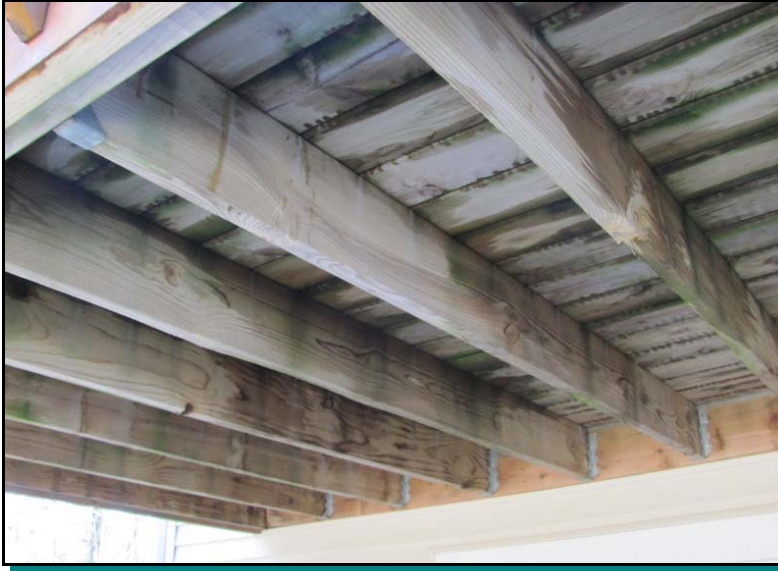
Wood balcony framing

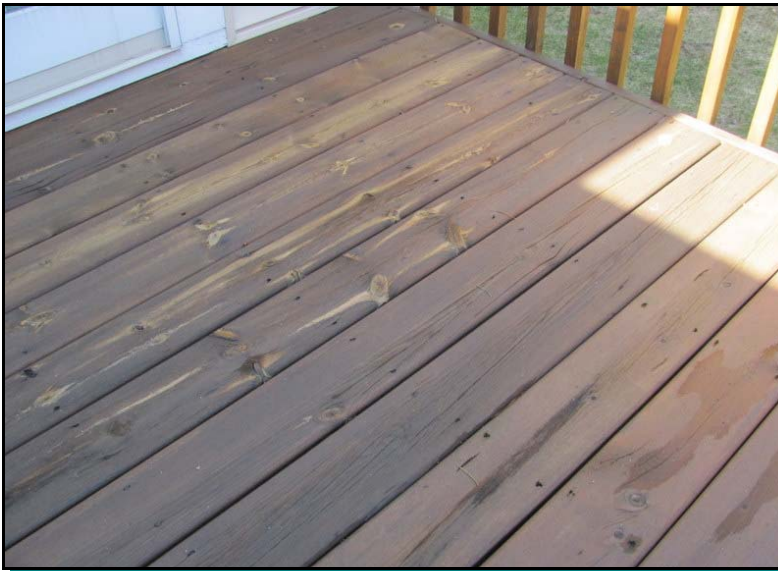
Deck boards, note minor stain deterioration

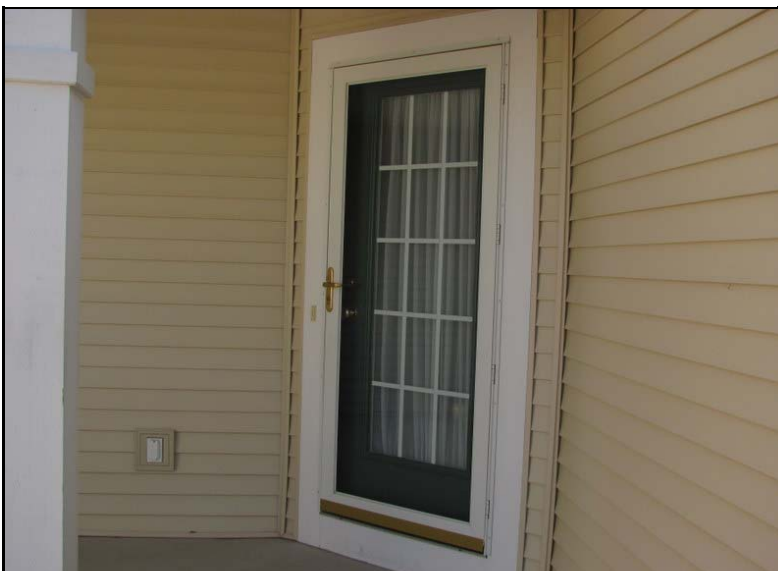
Doors, Front Entrances - Waterway Pines maintains 148 front entrance metal common doors. These doors are in good condition at ages of 7- to 15-years. Periodic maintenance of the entry doors should include applications of protective paint finish, funded through the operating budget. We anticipate a useful life of up to 30 years for the doors and recommend the Association anticipate a phased replacement of the doors beginning by 2026 and concluding by 2028. We depict this information on Line Item 1.180 of *Reserve Expenditures*.

Unit entrance

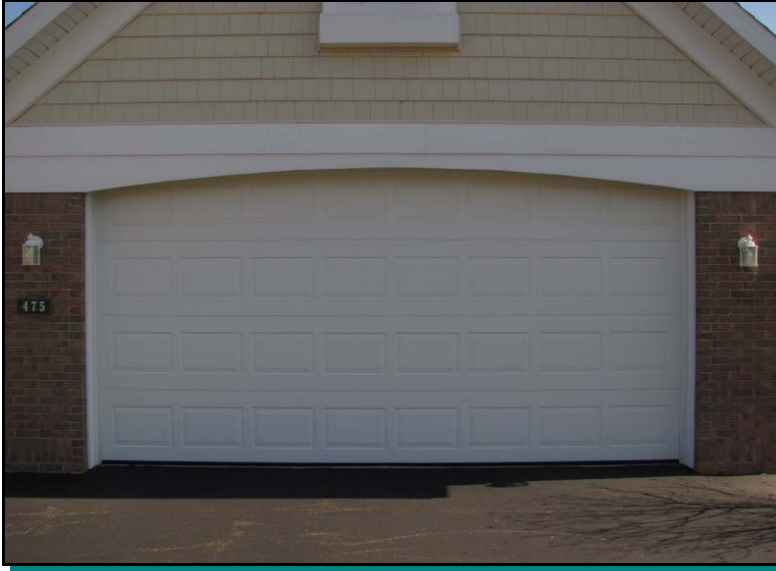
Doors, Garage - The Association maintains the 148 metal sectional garage doors throughout the development. Homeowners maintain the electric operators. The garage doors are in good to fair overall condition at ages of 7- to 15-years and have a useful life of 20- to 25-years. We recommend the Association anticipate a phased replacement of the garage doors beginning by 2022 and concluding by 2028 with insulated doors to provide structural rigidity to the panels. We note this information on Line Item 1.200 of *Reserve Expenditures*. Waterway Pines should aggregate replacement of the garage doors to ensure their availability and to maintain aesthetic continuity throughout the community.

Metal sectional garage door

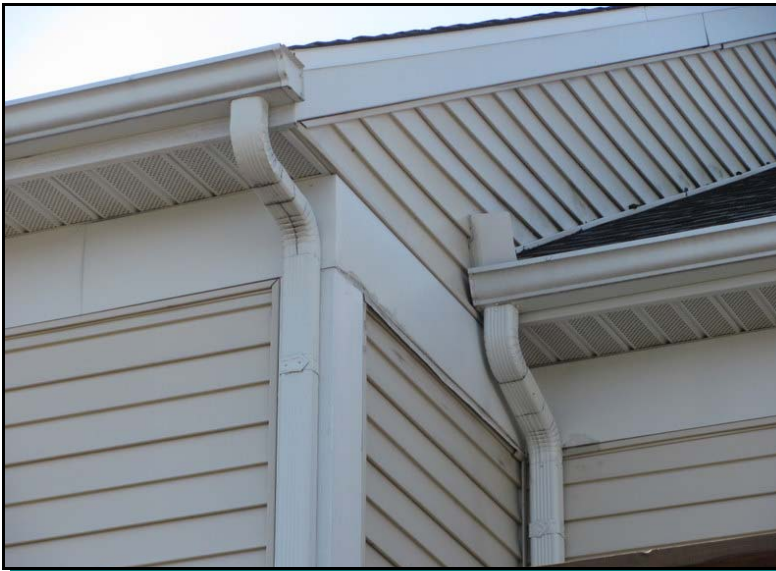
Gutters and Downspouts - Approximately 16,920 linear feet of aluminum gutters and downspouts drain storm water from the sloped roofs of Waterway Pines. These gutters and downspouts vary in condition from good to fair at ages of up to 15-years. We include the

Gutter and downspout assembly,
note kick-out flashing to direct
stormwater into gutters

The useful life of gutters and downspouts typically coincides with that of the roofs. Therefore, we recommend the Association budget for the phased replacement of the gutters and downspouts in conjunction with the phased roof replacements beginning by 2030 and concluding by 2033. This will result in the most economical unit price and minimize the possibility of damage to other roof components as compared to separate replacements. Due to the varied ages, we recommend the Association anticipate the need to replace limited quantities of gutters and downspouts prior to the complete phased replacement through the operating budget. We depict this information on Line Item 1.240 of *Reserve Expenditures*.

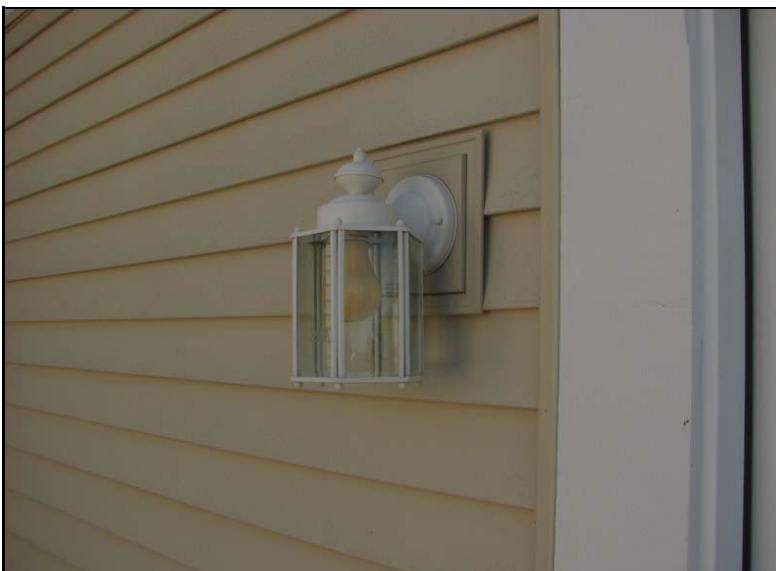
Light fixture at garage service
door

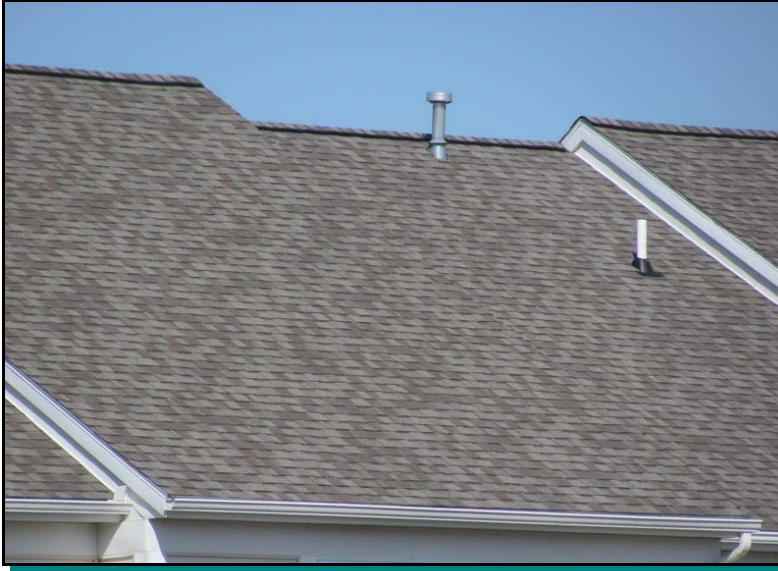
Roofs, Asphalt Shingles - Approximately 3,440 *squares*¹ of asphalt shingles comprise the roofs of Waterway Pines over 32 duplex and 21 fourplex buildings. The roofs are in good overall condition at an age of three years. Our visual inspection from the ground notes proper installation of flashings, drip edge flashing, and ridge vents. Soffit vents provide for additional attic ventilation. The useful life of asphalt shingle roofs in Holland is from 20- to 25-years. We include the following solutions and procedures pertaining to the *components* of an asphalt shingle roof system, *times* of replacement, recommended *method of replacement* and *coordination* of other related work for the benefit of present and future board members.

Asphalt shingle roof overview

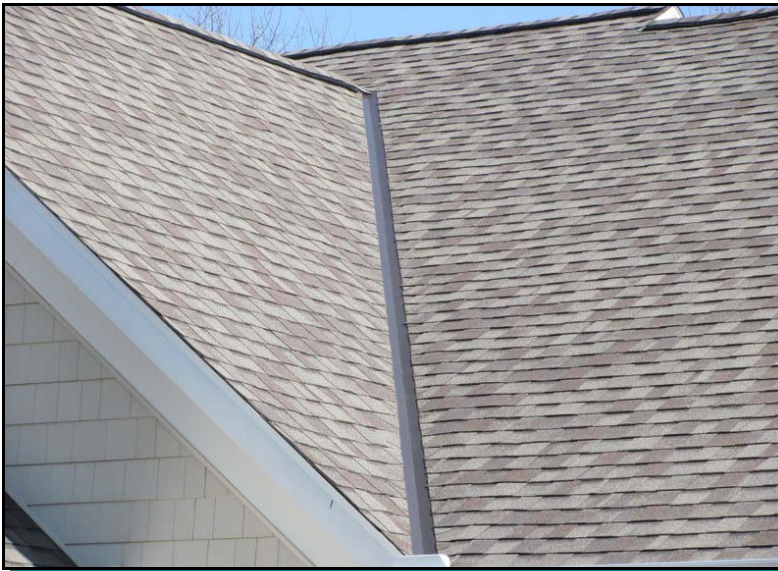
Valley flashing at roof

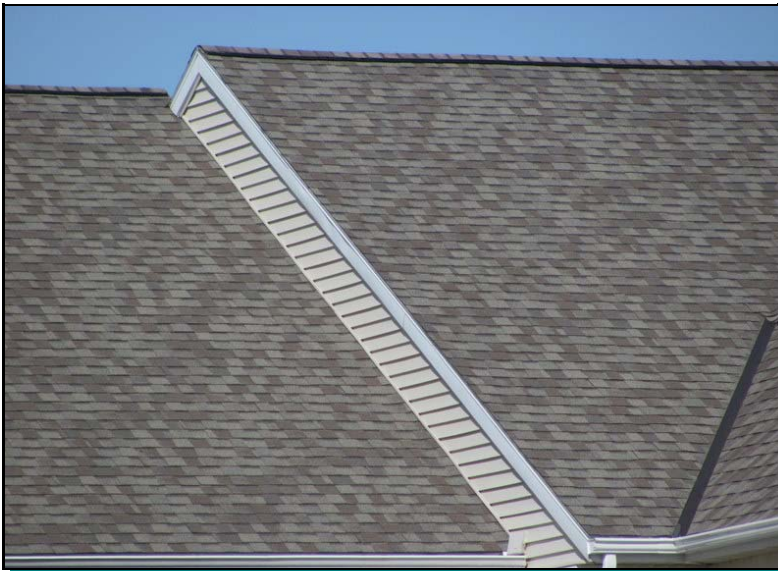
Roof overview

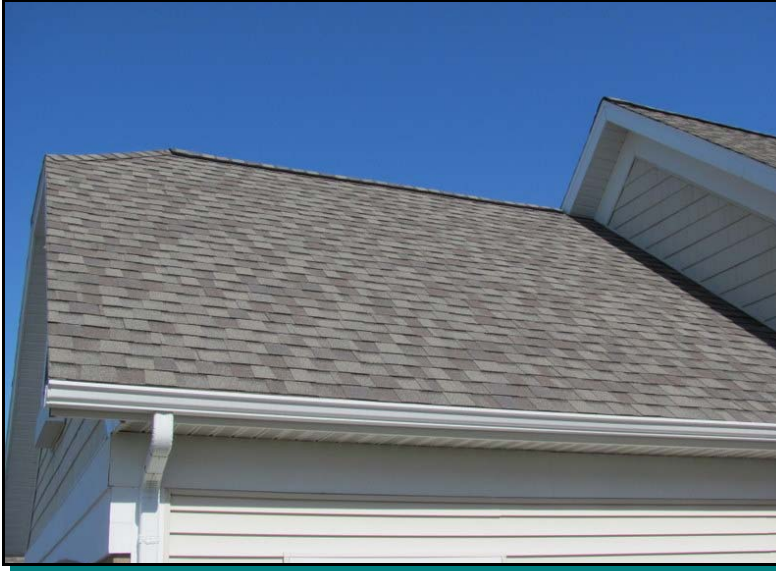
Asphalt shingle roof

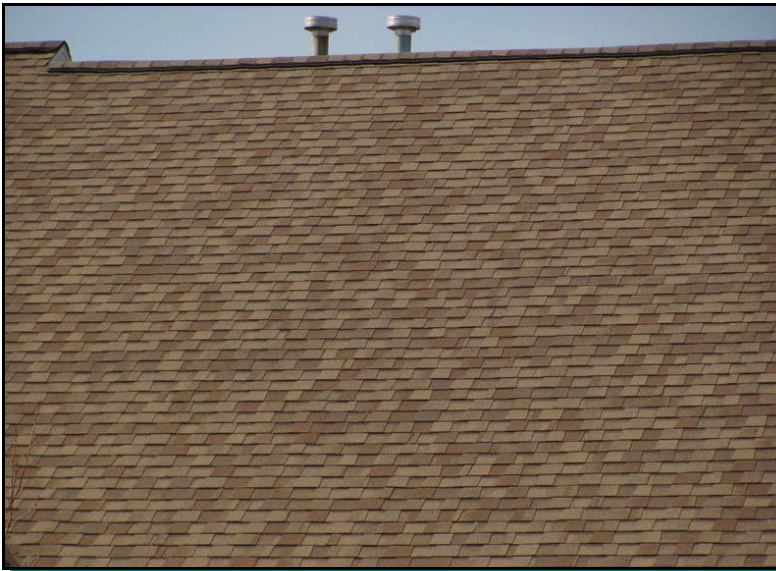
Roof overview

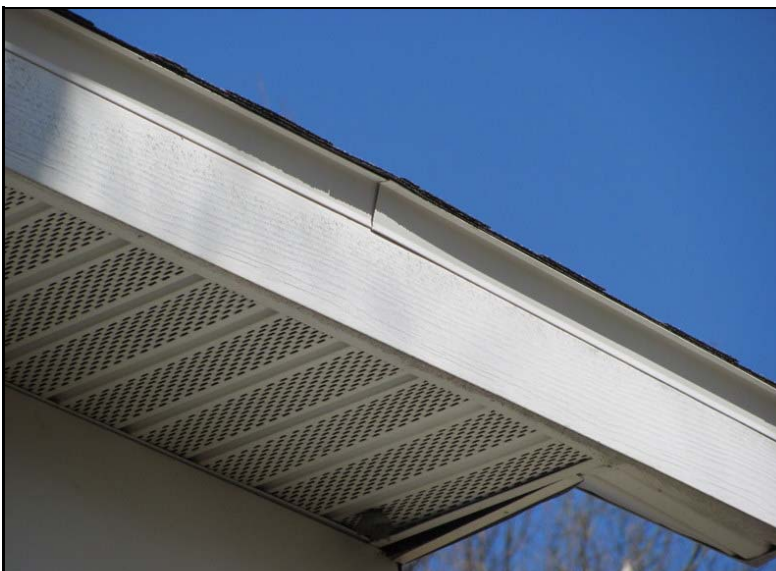
Drip edge flashing at roof

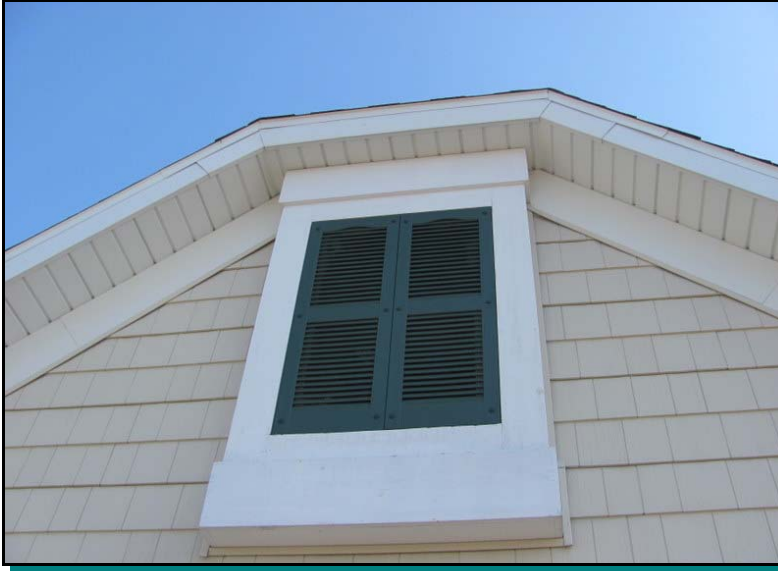
Decorative shutters

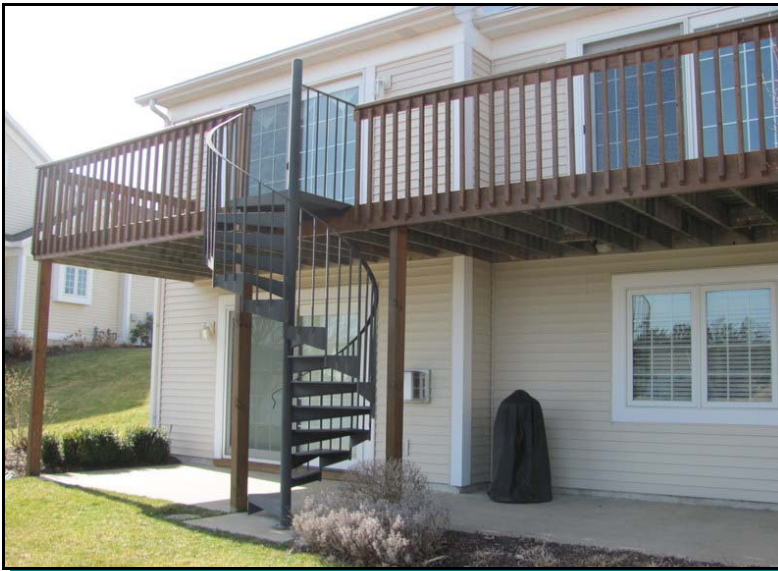
Metal spiral staircase at rear balcony

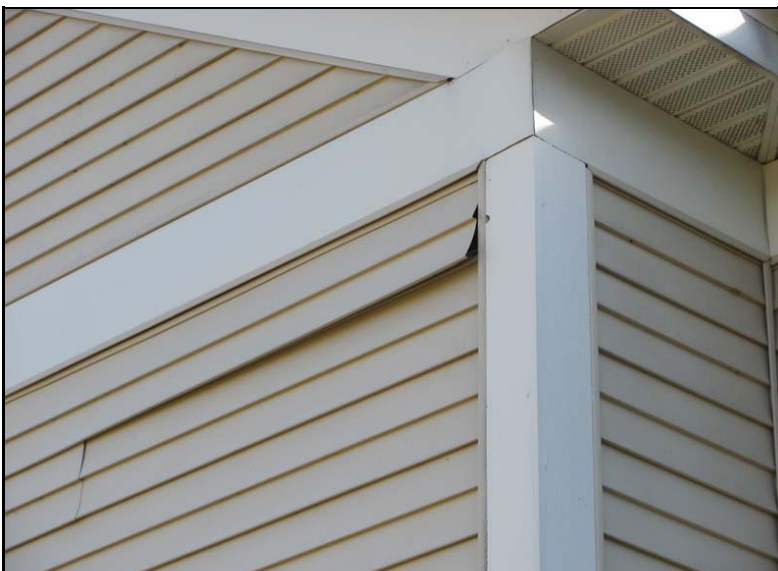
Isolated section of loose vinyl siding, 412 Timber Lake West

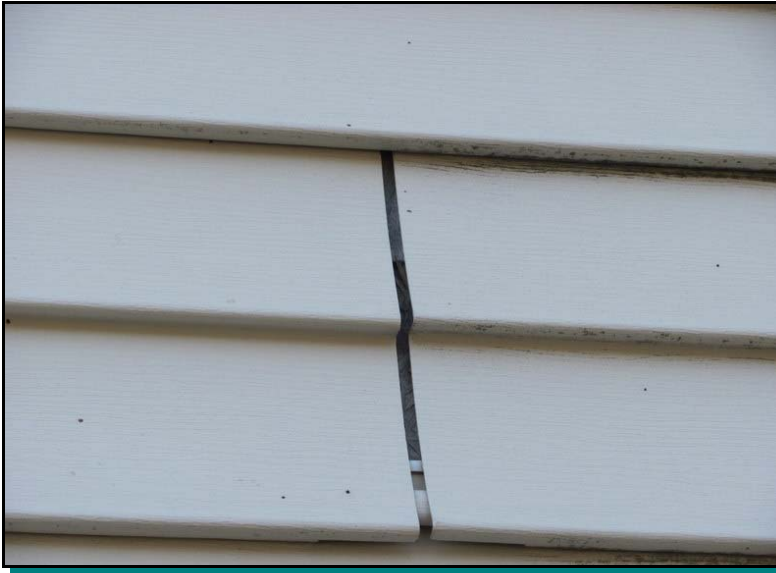
Gap in vinyl siding, note lack of building wrap

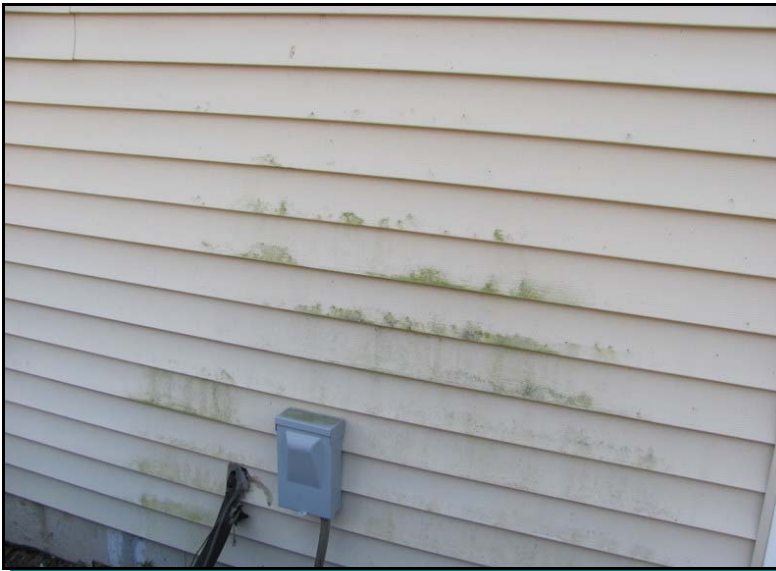
Organic growth at vinyl siding

Fund periodic cleaning through operating budget

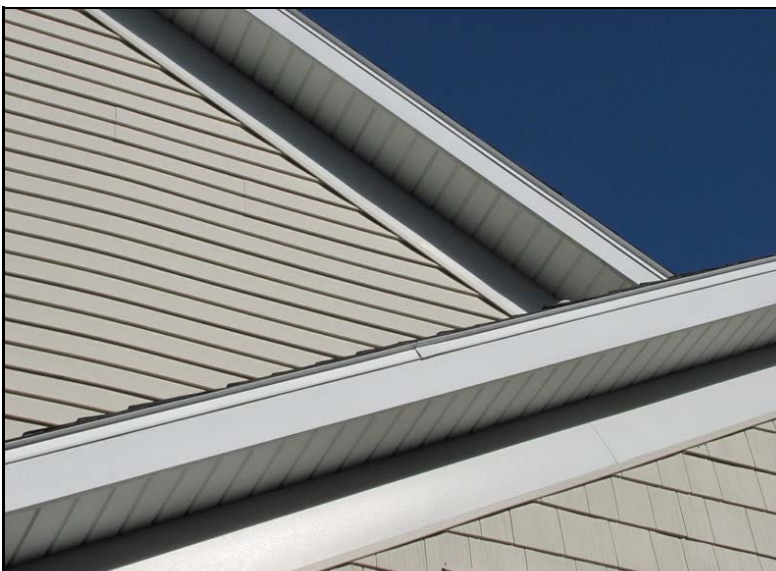
Vinyl siding with aluminum soffits

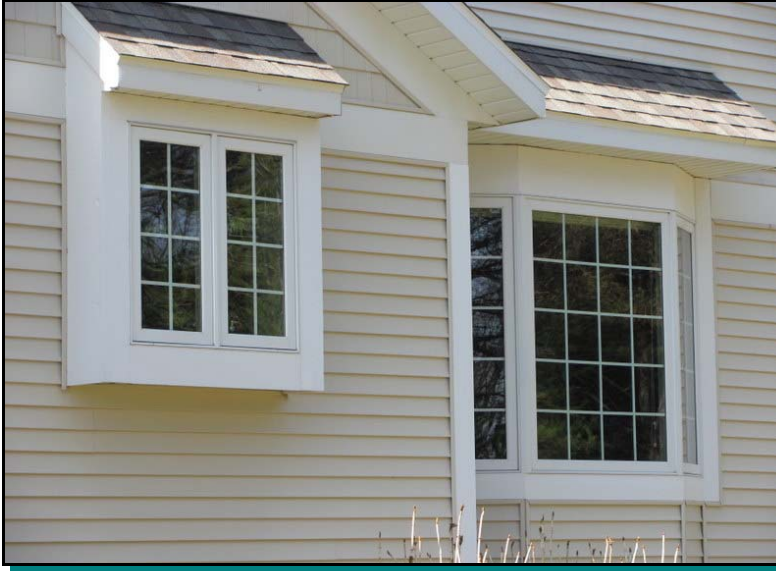
Vinyl frame windows

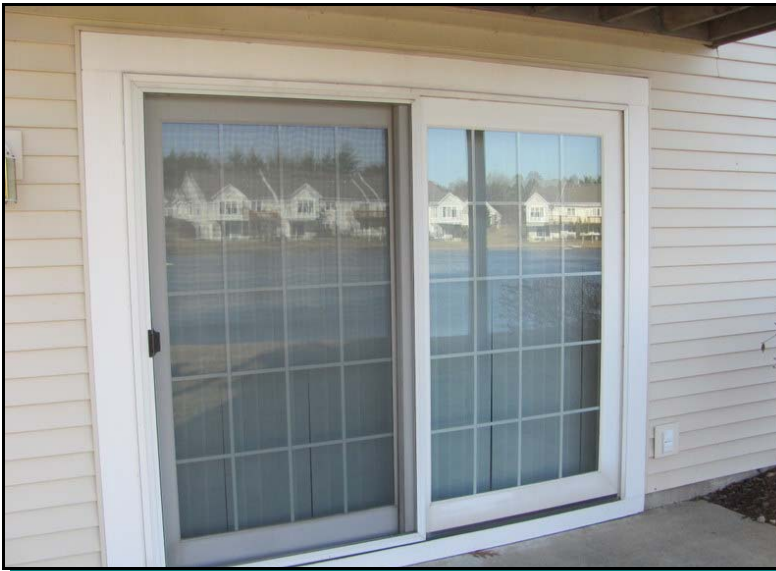
Patio door

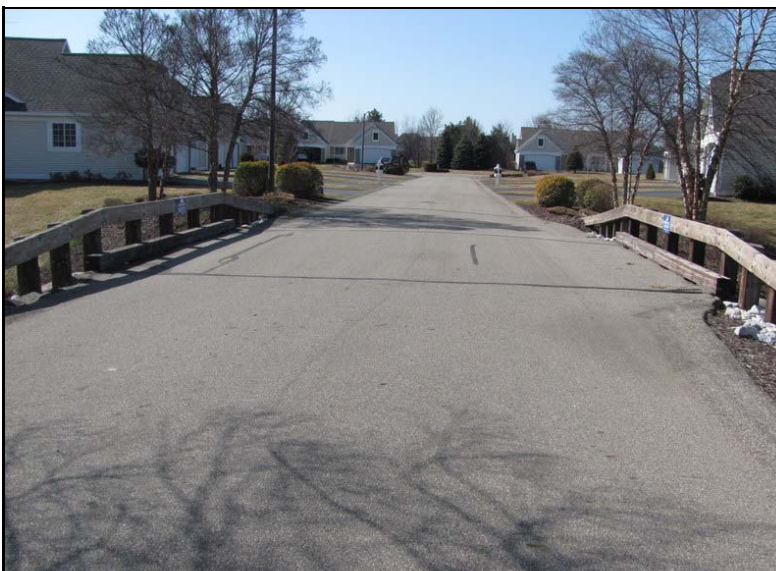
Asphalt Pavement, Repaving - The 16,700 square yards of asphalt streets, parking areas and driveways throughout the community are in fair overall condition at an age of approximately 15 years. We note widespread areas of previous crack repair, edge cracks, centerline cracks and transverse cracks in the street pavement, and surface deterioration and developing fatigue cracks in the driveway pavement. Pages 5.11 through 5.13 of *Photographs* depict these conditions. The useful life of pavement in Holland is from 15- to 20-years. We include the following solutions and procedures pertaining to *components* of the pavement, the *manner of repaving*, *time* of repaving and *coordination* of other possible replacements with the repaving for the benefit of the present and future board members.

Asphalt pavement overview at
Timber Crossing bridge

The *manner of repaving* is either a *mill and overlay* or *total replacement*. A mill and overlay is a method of repaving where cracked, worn and failed pavement is mechanically removed or milled until sound pavement is found. A new layer of asphalt is overlaid atop the remaining base course of pavement. Because of the milling, the new layer of pavement will be flush with adjacent catch basins and driveways. Total replacement includes the removal of all existing asphalt down to the base course of aggregate and native soil followed by the application of two or more new lifts of asphalt. We recommend overlayment on asphalt that exhibits normal deterioration and wear and lacks adjacent driveways or catch basins. We recommend total replacement of asphalt pavement that exhibits severe deterioration, inadequate drainage, pavement that has been overlaid multiple times in the past or where the configuration makes overlayment not possible. Based on the apparent visual condition of the asphalt pavement, absence adjacent curbs, and a bid provided by the Board, we recommend the *mill and overlay*

method of repaving for the streets at Waterway Pines. In addition, we recommend the *total replacement* method for subsequent street repaving and repaving of the asphalt driveways.

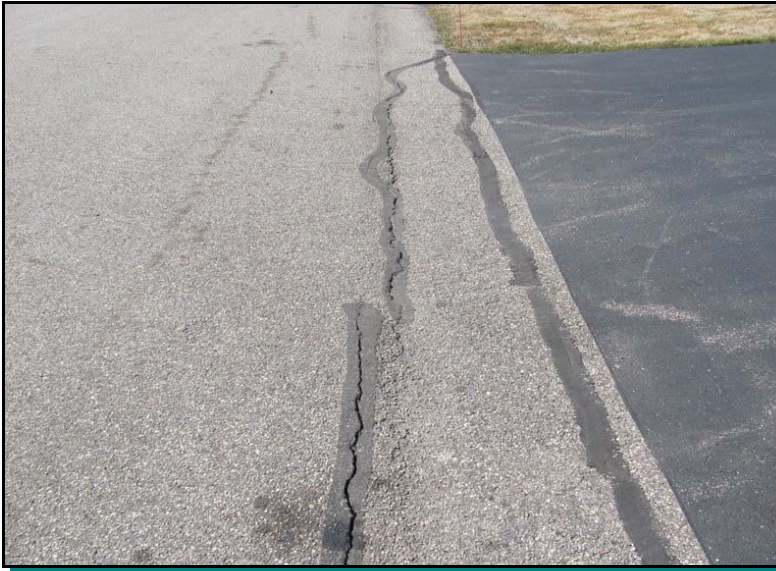
Edge crack and previous crack repair at asphalt street

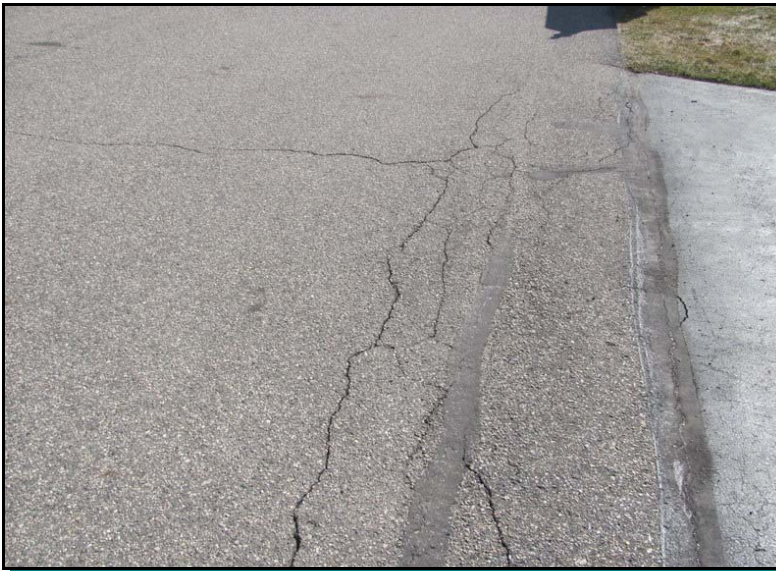
Edge cracks

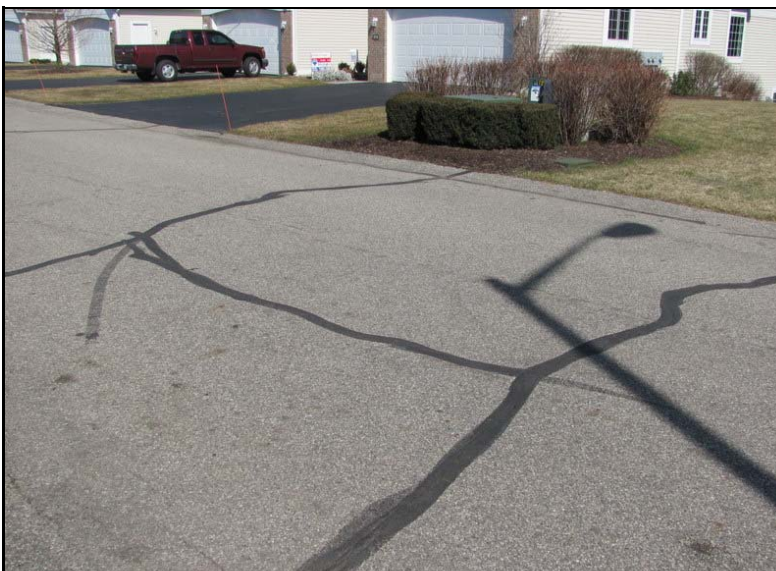
Longitudinal and transverse crack repair

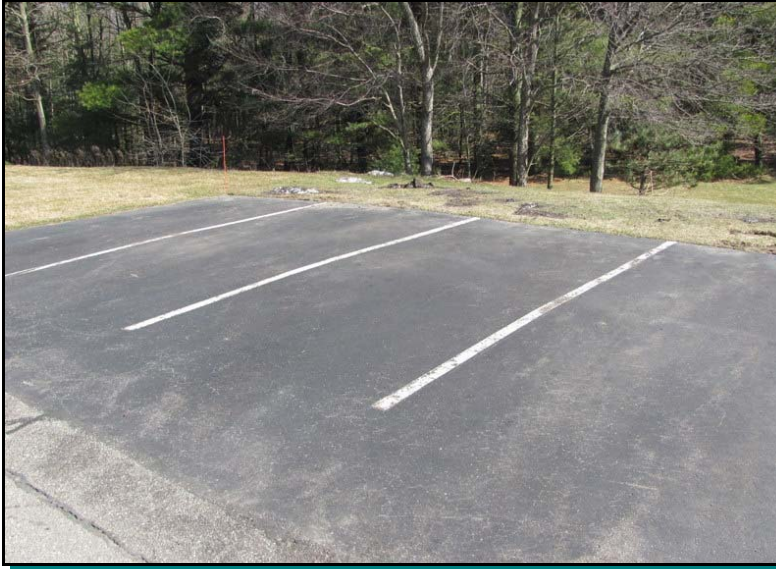
Asphalt parking area

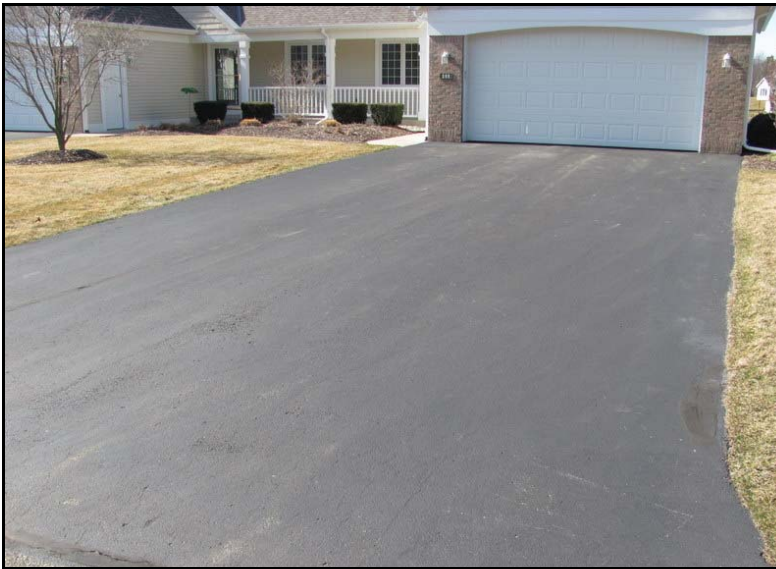
Asphalt driveway overview

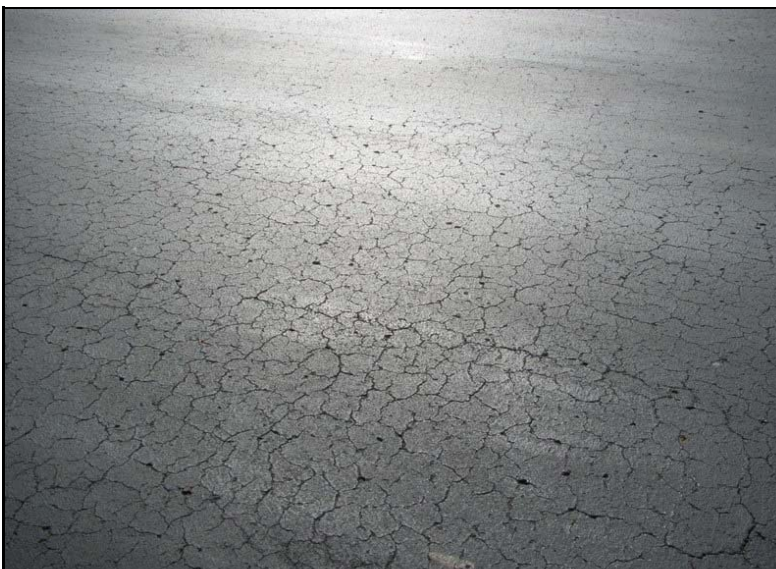
Surface deterioration at driveway

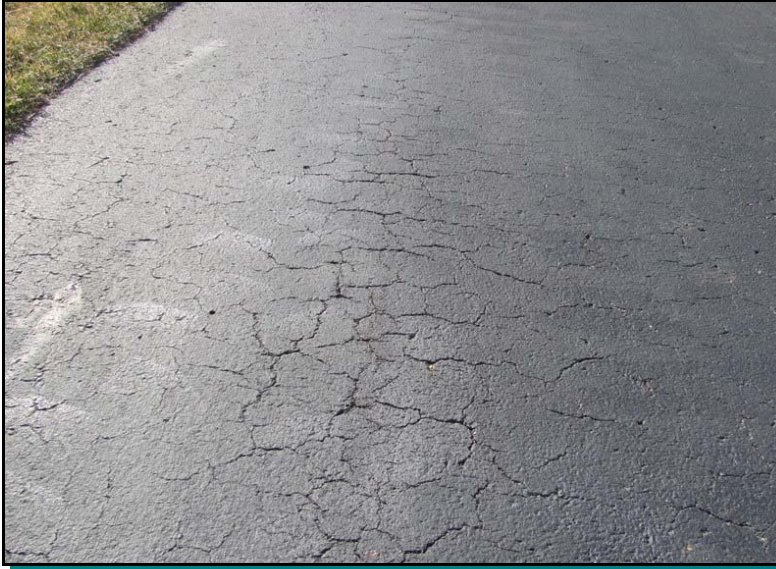
Surface deterioration and developing fatigue cracks at asphalt driveway

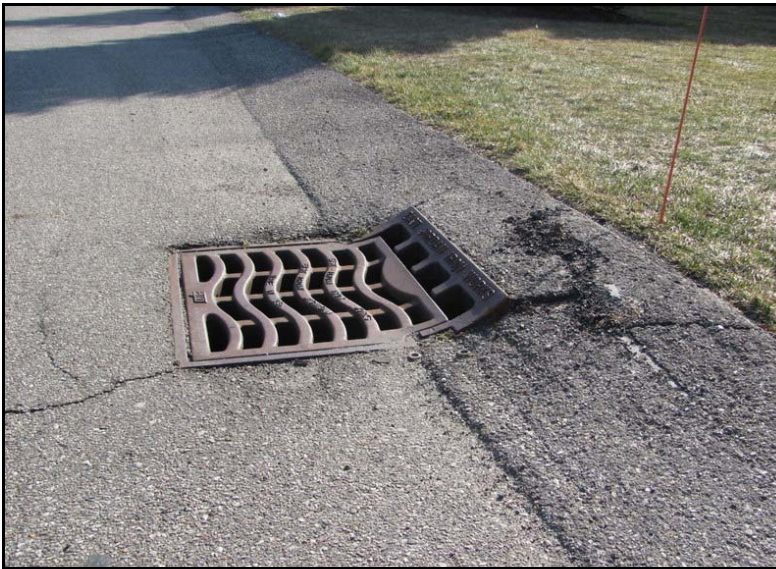
Catch basin

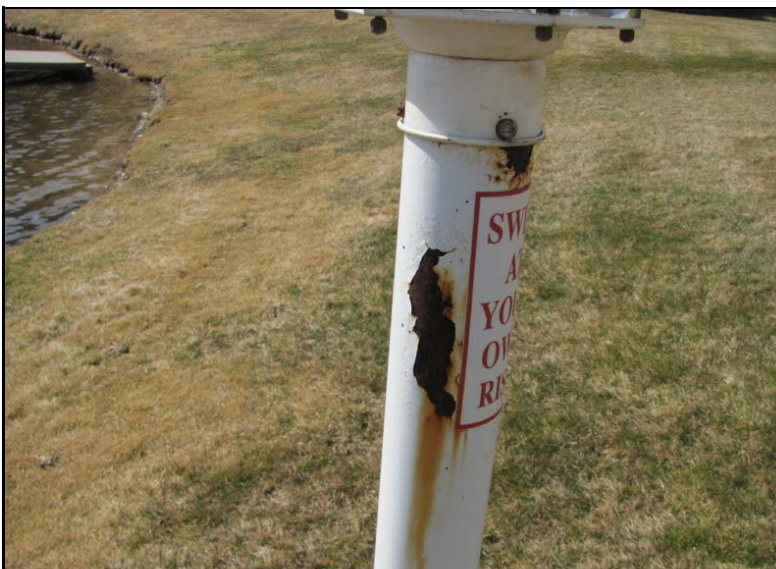
Light pole finish deterioration

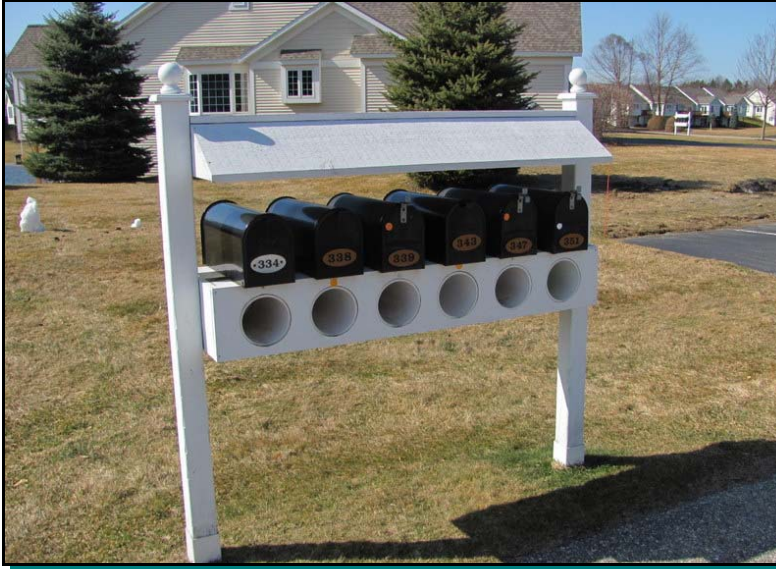
Mailbox station

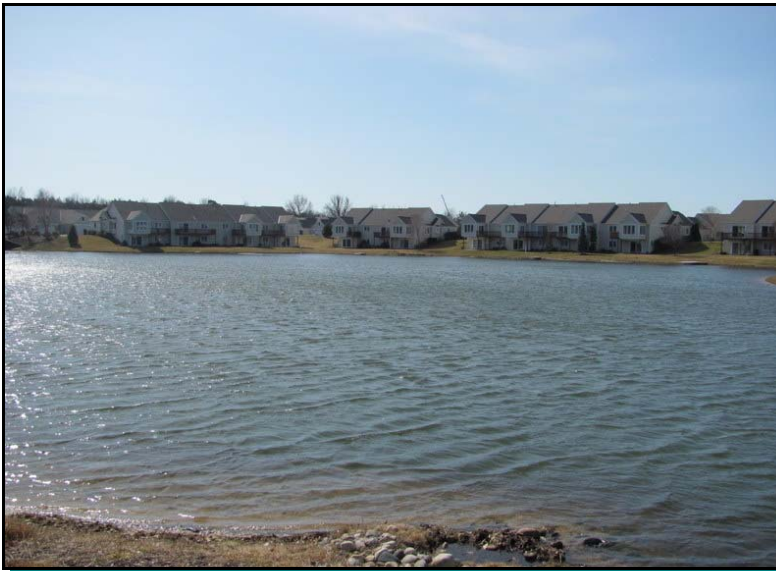
North pond overview

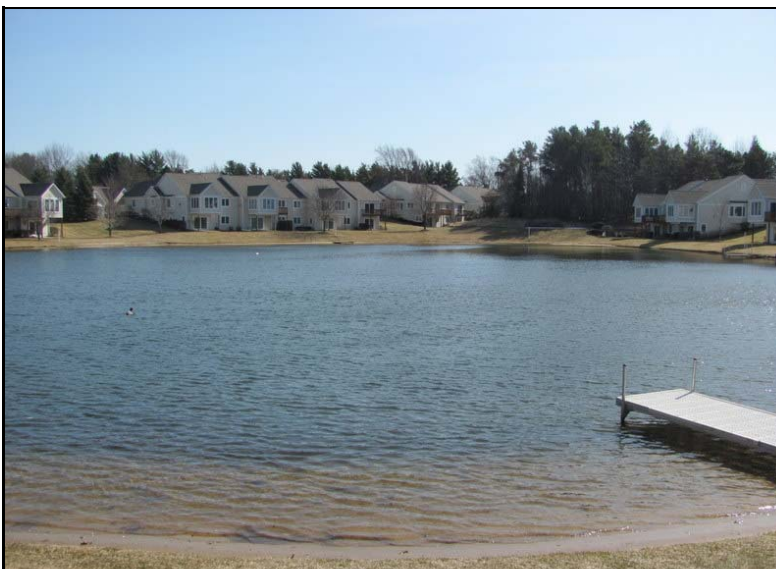
South pond overview

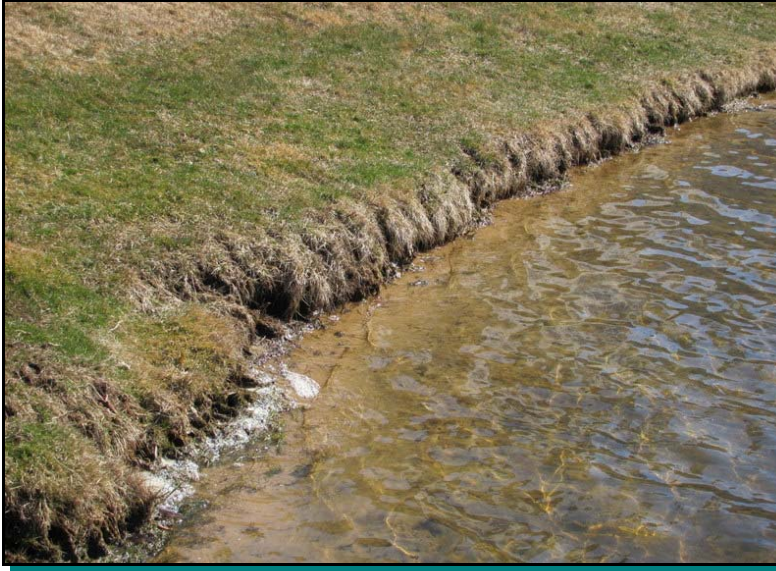
Minor shoreline erosion

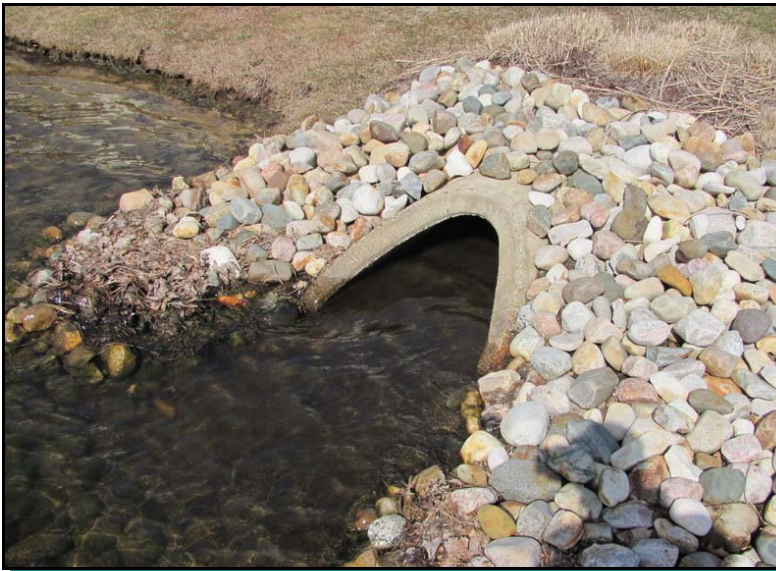
Concrete drainage structure

Long-lived element
